# Engineered solution

**PowerMax Engineering has a remedy for the troublesome oil pump drive on the 2.0 TDI engine.**

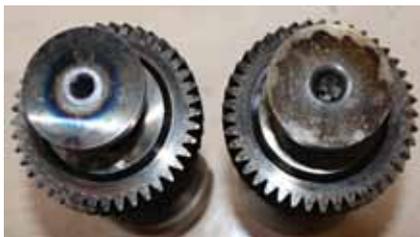
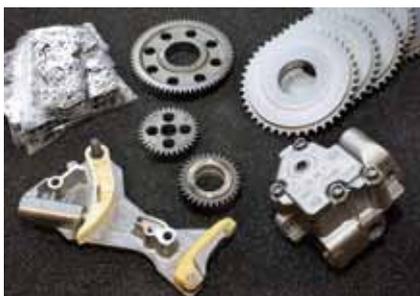
**A KNOWN problem with the Volkswagen Group 2.0-litre TDI engines from 2005 onwards\* is that of oil pump failure, due to wear of the hexagonal shaft drive from the end of the balancer shaft.**

However, a combination of lack of perfect concentricity and the inevitable wear between the drive grooves and the hexagonal shaft which occurs after a high mileage (70,000 or so), can cause slippage or even complete loss of drive to the oil pump, resulting in loss of oil pressure and subsequent damage to the engine if the warning light isn't noticed in time.

We've recently come across a company in Northern Ireland, PowerMax Engineering, which has developed a process to re-manufacture the existing balance shaft, using a new hardened keyway pressed into place. This allows the use of an OE key to drive the oil

**'POWERMAX ENGINEERING RE-MANUFACTURES THE EXISTING BALANCE SHAFT, USING A NEW HARDENED KEYWAY PRESSED INTO PLACE'**
