# Engineered solution

**PowerMax Engineering has a remedy for the troublesome oil pump drive on the 2.0 TDI engine.**

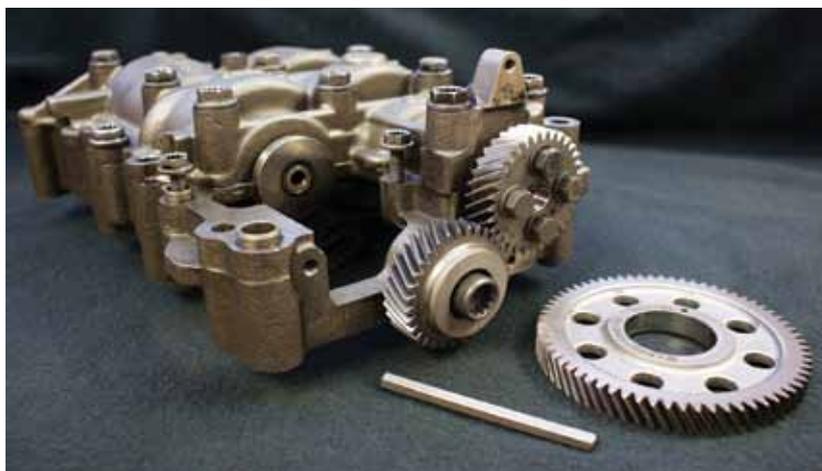
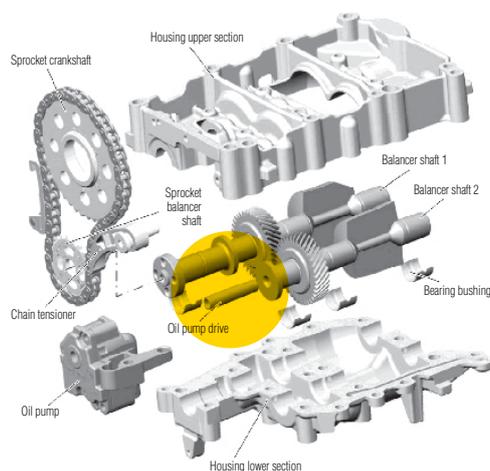
**A KNOWN problem with the Volkswagen Group 2.0-litre TDI engines from 2005 onwards\* is that of oil pump failure, due to wear of the hexagonal shaft drive from the end of the balancer shaft.**

While earlier engines had the oil pump driven by a short chain directly from the crankshaft, the introduction of balancer shafts to improve the refinement of the later engines required the oil pump to be relocated and driven directly from the second balancer shaft using a short 6 mm hexagonal shaft.

Very similar in appearance to the straight shank of an Allen key, approximately 75 mm long, this engages in a drive socket in the end of the balance shaft, comprising a bore with machined grooves which locate on the points of the 6 mm shaft.

However, a combination of lack of perfect concentricity and the inevitable wear between the drive grooves and the hexagonal shaft which occurs after a high mileage (70,000 or so), can cause slippage or even complete loss of drive to the oil pump, resulting in loss of oil pressure and subsequent damage to the engine if the warning light isn't noticed in time.

We've recently come across a company in Northern Ireland, PowerMax Engineering, which has developed a process to re-manufacture the existing balance shaft, using a new hardened keyway pressed into place. This allows the use of an OE key to drive the oil

pump, which is supplied as part of the package. The cost of the service is £355.
